TOWN OF WESTON COMMUNITY PRESERVATION COMMITTEE
Project Submission Form – FY17

Notes on Case House

Weston Historical Commission: Historical and Architectural Restoration of the Case House

School Administration Building
 CASE HOUSE
 Existing Conditions Study
 Weston, Massachusetts

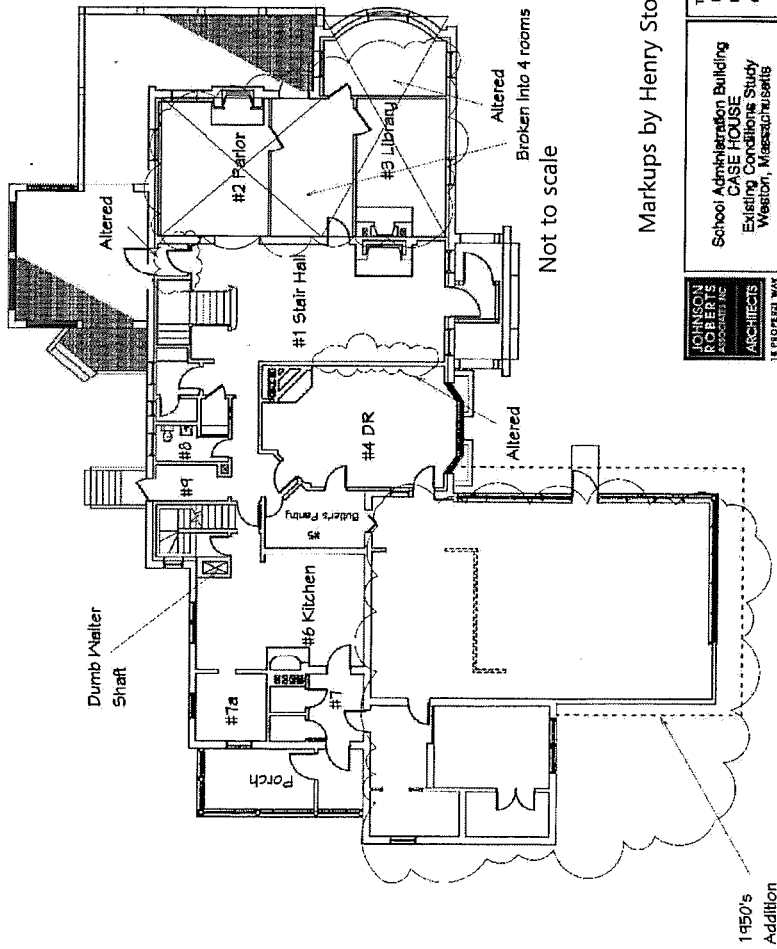
Title:
 EXISTING CONDITIONS
 FLOOR PLAN
 GROUND

1. Main stair Hall and stairs. (Note spectacular exposed hewn frame ceiling including pegged through-tenoned headers at fireplace and stairs and handsome ceiling boards above)*. Wainscot and wall paneling are rift/quartered white oak, beautifully detailed. Grand fireplace, complete with carved brownstone mantel and carved motto, as well as unusual brick face and firebox; the bricks speckled heavily with reduction iron spots.

- ii. Heavily detailed wall (maybe with pocket doors, or arch) that connected DR to Stair Hall was demolished This has done severe damage to the architectural integrity of both rooms. *Original relationship between the rooms should be restored. I would guess that there were pocket doors or large swinging French doors set in a double-thick wall leading from the Stair Hall into the Dining Room. This doorway is lost, and the removal of the double wall has resulted in the loss of the cornice and all paneling and detailing on both sides of it. This should be recreated/restored.*

- iii. Covering of floor with WW carpet, including some glued down. Floor probably is/was rift/quartered white oak with cherry border to

- iv. *What is wood species and original finish of exposed frame ceiling?
Probably oak. *Restore to original finish.*
- b. Painted wainscot and trim at West front door. Note damage to frieze at ceiling; probably insulation drilling. *Remove 50's era partitioning. Repair and restore to original finish*

2. & 3. Parlor (2.) and Library (3.): Originally these were two large and graceful rooms (now chopped awkwardly into 4 offices) both with elegant fireplaces and, in the case of the Library, a curved window bay. They may have had pocket or double doors between them but the partition that would have held them is lost. Some of the original wall paneling and shelving of the library was preserved in the conversion, much lost. Based on looking at a very small scraped area, this work may be mahogany, though more likely oak. The door into the Library is old, but not original, of poplar, badly stripped and not quite matching the original doors. *These rooms should be restored to their original configuration and finishes:*

- i. *As noted above, original lighting should be restored.*
4. **Dining Room:** This was undoubtedly a fabulous room, much damaged by the 50's changes. The loss of the original partition between this room and the adjoining Hall has destroyed a good percentage of the oak woodwork and finishes that would have matched the opposite wall and framed the wonderful built-in sideboard and niche at the end of the room. A new door into the 50's addition was awkwardly punched through the paneled wall that is left. The floor is covered with w/w carpet. There is probably more of the oak and cherry seen in the other rooms under.

8. **Original Hall Half Bath:** Surprisingly, this little gem has survived, in particular the white marble walls and floors and the sink top and bowl. (Written in crayon on the underside of the marble top it says "Case House #1"). The original nickel plated spout and part of a pop-up mechanism (which I've never seen before) for the drain stopper is still there. I would love to identify that pop-up and see if it can be put back. The H&C valves are chrome and not original but very good replicas are available as well as restored old ones. (Note that the original supply piping appears to still be in place – plated brass - and failing). The toilet room has the original carved marble toilet base plate with a modern toilet badly mounted on it. A good restored or replica high-tank toilet could be used to replace the modern one.

- All of entrance and stair hall, and stair case, with large fireplace (#1 on marked up drawing)
- (Note: missing porte-cochere outside of east entrance)
- All Rooms with fireplaces (#2,3,4)
- Original Half-Bathroom (#8)

- a. Stair Hall with grand fireplace somewhat intact. Except:
 - i. Added double entrance area at E door by main stairs. *Remove this; appears that there used to be two doors hung back to back in the opening. Could install bronze interlock weather stripping and perhaps reproduce the original two door setup.*

- a. *Remove 50's era partitioning.*
- b. *Frame and finish new partition at location of lost one between Parlor and Library, including installing door(s) as close to original as can be determined.*
- c. *Note that when the Library was partitioned, some of the trim around its fireplace was cut off and damaged and all the trim on both sides of the original partition between the Library and Parlor was lost. Door(s) between them were also lost. Should be restored and the original replicated*
- d. *Remove acoustic and dropped ceilings, restoring original cornices common to both the rooms and repair/replace lost plaster.*
- e. *Floor will need extensive and careful patching to match original (oak and cherry) and refinishing*

- a. *The partition shared with the Hall should be replaced and reproduced. (See note above: Main Stair Hall, a. ii.)*
 - b. *Oak woodwork should be stripped and refinished to its original state and to match the other formal first floor rooms. The built-in casework and decorations of the side board niche should be fully restored. Note delicate lozenge and bead at wainscot rail that needs to be reproduced and replaced where missing.*

- c. *Original floor should be exposed and restored, as noted above.*
 - d. *There are two hanging light fixtures which are cheap replicas imitating gas lamps. I don't know what was there originally, but this needs to be identified and fixtures in character with the era (probably converted gas) installed. The notes above regarding lighting apply here as well.*

- a. *Fully restore as suggested above.*

2. **First floor public areas:** Restoration of the original layout and detailing including the following;
 - Stair Hall; at the south door wall; strip off paint and restore the original oak wall and door trim. (All of Stair Hall; the oak ceiling planking, as well as the exposed hewn oak floor beams, probably originally had a clear finish. Even if it is determined that the original finish was clear, maybe stripping these is not a high priority).

- Removal of the carpet from the tile floor of the Entrance Hall (#1) and restoration of the tile.
 - Restoration of the Parlor (#2) and the Library (#3) to their original layout and of their original paneling, trim, cornices etc. and reproduction of the original doors and doorways between them. Note current replacement door from Hall to Library; it is not oak (poplar, gum) and not a match to the original. Should be replaced with replica door in quartered/rift oak. *(More research needed to try and determine how the two rooms were connected. The trim, paneling etc. can be extrapolated from what is there).*

- Removal of all dropped ceilings and restoration of ceiling and crown moldings etc.
 - Restoration of the wall and the doors between the Dining Room (#4) and the Stair Hall (#1). It appears that the original wall was double thickness which would indicate that pocket doors connected the two spaces, probably lined up with the grand Stair Hall fireplace. *(More research is needed to try and determine how the two rooms were connected. The trim, paneling etc. can be extrapolated from what is there).* Included in the Dining Room restoration is to remove the doorway that was crudely punched through the wall to connect to the 50s addition. Restore the paneling there. Strip and refinish the built-in Dining Room hutch and surrounding trim.

- Restore, including the vintage fixtures, the old half-bath off the Stair Hall (#8)
 - Repair all woodwork as needed and refinish as needed.
 - Sand and refinish all wood floors

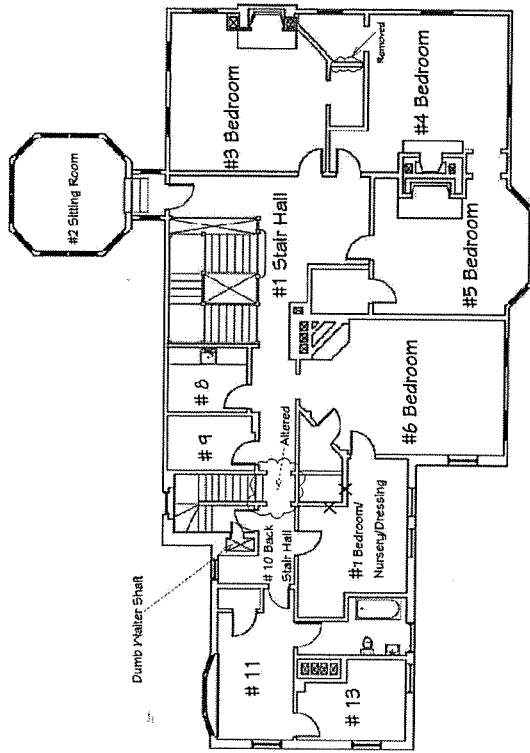
Title:
EXISTING CONDITIONS
FLOOR PLAN
SECOND

1. Stair Hall: In very good shape. It is one step down in fanciness from the first floor as the wainscot paneling appears to be yellow pine or maybe poplar (gum wood?) with a semi-transparent colored varnish as a sort of faux oak. The molding profile matches the first floor. The other wood trim (baseboards, door and window casings) appears to be either poplar or gum wood - probably the same as the wainscot and are consistent profiles, surely original. The floor (throughout the central corridor) is rift/quartered white oak, very worn at the top of the stairs. The plaster walls have a grainy texture that should be preserved or replicated as needed.

It appears that originally the central hall ran uninterrupted from the front stair hall to the back. Two later walls and doorways were clumsily installed to separate the two stair halls. The wainscot trim was mostly left intact under the changes and the full sweep of the halls could be brought back.

- d. *See notes above about lighting.*
2. Eight-sided Sitting room: This is a spectacular little space over the secondary west entrance door and porch below - a show-stopper! The floor has w/w carpeting and given how the rest of the surfaces are treated, is probably wonderful. All the other surfaces – casings, pilasters, brackets, paneling, dentils and ceiling coffers are made of quilted mahogany. The ceiling plastered panels are heavily textured and there is a frieze band along the top of the wall that is smooth painted plaster. I wouldn't be surprised if there had been a decorative paint, paper or even gilt, treatment to that band. The wood is in great shape, but its finish is completely gone. Years of sun and no attention have left it appearing stripped and with raised grain as if someone had actually used stripper on it to remove paint. It was probably shellacked.

There is evidence of roof leaks and it is imperative that this room be completely protected from the elements. This means a proper long-lived roof such as slate or copper (whatever it was originally) and may entail dealing very carefully with insulation and heating (now electric baseboard) and cooling so condensation is not an issue and so the floor is warm (probably why it was carpeted).

3, 4, 5 and 6: Bedrooms: All four of these rooms appear to be essentially in their original state. The floors are southern yellow (long-leaf) vertical grain pine (SYP) in fine shape needing only sanding and refinishing. The walls are all smooth plaster (maybe papered originally) and in good shape. The trim and fireplace surrounds are all painted wood and are probably yellow pine or poplar under the paint. They may have had a treatment similar to the Hall trim, or always were painted. At any rate careful investigation will be required to see how, or if, they should be restored. All four rooms have large fireplaces with nice mantels and surrounds and are each a different design. The masonry seems generally good, but see my notes re. fireplaces above. Even the fire boxes are each a different design incorporating diverse shapes, bricks and at least one cast-iron fire back. Room 5 has a door in the middle of the bay that used to lead out to a porch above the missing porte-cochere.

- Stair Hall up to doorway at back stair hall
- All rooms with fireplaces (#3,4,5,6)
- Eight-sided Sitting Room (#2)

- a. *Floors need careful refinishing as they show some evidence of being thin. Should come up fine and in the future not be allowed to wear through before being re-coated.*

- b. *The rest of the wood trim needs cleaning and a light refinishing.*
 - c. *Removing the partitions and doors to restore the hall to its original layout will require some restoration of the wainscot and refinishing. Would present a wonderful light-filled interior prospect.*

- a. *The floor needs to be exposed, repaired as needed and refinished properly.*
- b. *The wood work will respond spectacularly to skilled refinishing. The grain will pop and the color should be beautiful.*
- c. *Lighting; see above*

- a. *Floors refinished.*
- b. *General painting and associated repairs*
- c. *Mason's assessment and work as indicated (see above)*
- d. *Lighting; see above*

3. **Eight-sided sitting Room** off second floor stair hall (#2); The original (probably) quilted mahogany paneling, moldings, trim and brackets are in very good shape, as are the plastered surfaces, other than some water staining. The whole of the walls, window surrounds and ceiling need very careful refinishing. The floor is covered in w/w carpet which should be removed and the floor under restored (replicated if missing). *The toughest challenges for this room are introducing insulation and mechanical systems without destroying the historical fabric, and the issue of accessibility. The latter may require some sort of variance and/or dispensation from the state.* It is WHC's opinion that this room needs extraordinary attention and effort at restoration: very special and very unusual.

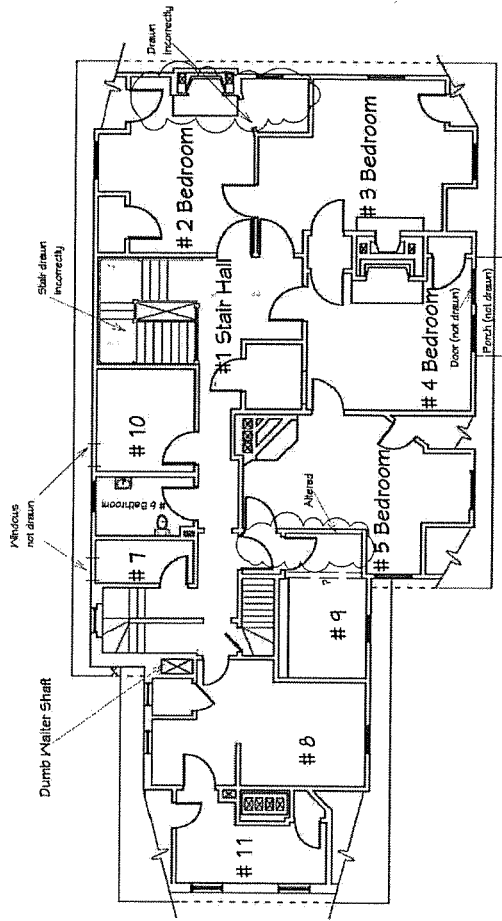
Title:
 EXISTING CONDITIONS
 FLOOR PLAN
 THIRD

1. Stair Hall: In good shape and continuous with the Stair Halls below it. Another step simplified from the Halls below, but still really nice and worth restoring. The floor is SYP in great shape. The trim is the same as the floor below, with a transparent colored varnish in good shape, though the wainscot is reduced in height, simplified and leaves off at the top of the stairs.

2, 3, 4, and 5.: Bedrooms: These, as is the case on the floor below, are the rooms with fireplaces. They are another step more modest than the fireplaces on the floor below, but they are still very nice and each unique. The floors, where not carpeted, are SYP, and I suspect under the carpets are as well. Two rooms (4 and 5) have the transparent finish on the wood work and the others are painted. There is a nice ceiling treatment in rooms 2 and 3.

- Stair Hall up to doorway at back stair hall
- All rooms with fireplaces (#2,3,4,5)
- Porches off bedrooms

- a. *See basic recommendations for Stair Hall above*

- a. *See basic recommendations for the four bedrooms on the floor above*
- b. *It appears that room 5 originally was connected internally to room 9 (bedroom – nursery/dressing room?) and the small hall awkwardly built to make 9 private. Putting it back as it was would make both 5 and 9 a lot nicer.*
